Preliminary Arborist Report

To: Hultquist Homes c/o Greg Rumsey
Site: 755 5th Ave Northwest, Issaquah, WA, 98027
Re: Tree Inventory and Assessment
Date: September 16, 2022
Project Arborist: Connor McDermott,
ISA Certified Arborist #PN-8704A
ISA Qualified Tree Risk Assessor
Reviewed By: Tyler Bunton,
ISA Certified Arborist #PN-8715A
ISA Qualified Tree Risk Assessor
Referenced Documents: Issaquah 3 Town Homes, Site Plan A0.0 (Medici Architects 09/07/2022)
Topographic Survey (Informed Land Survey 01/07/2019)
Attached: Table of Trees
Tree Site Map

ISSAQUAH 3 TOWNHOMES

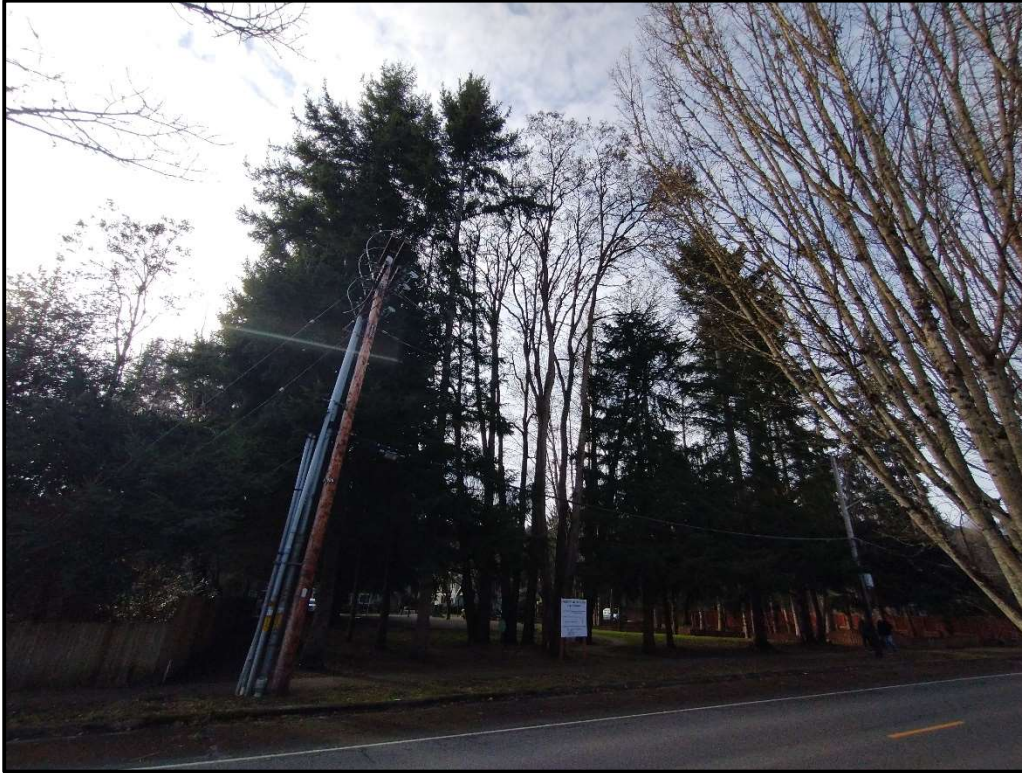
Photo 1. Site viewed from the street to the north.

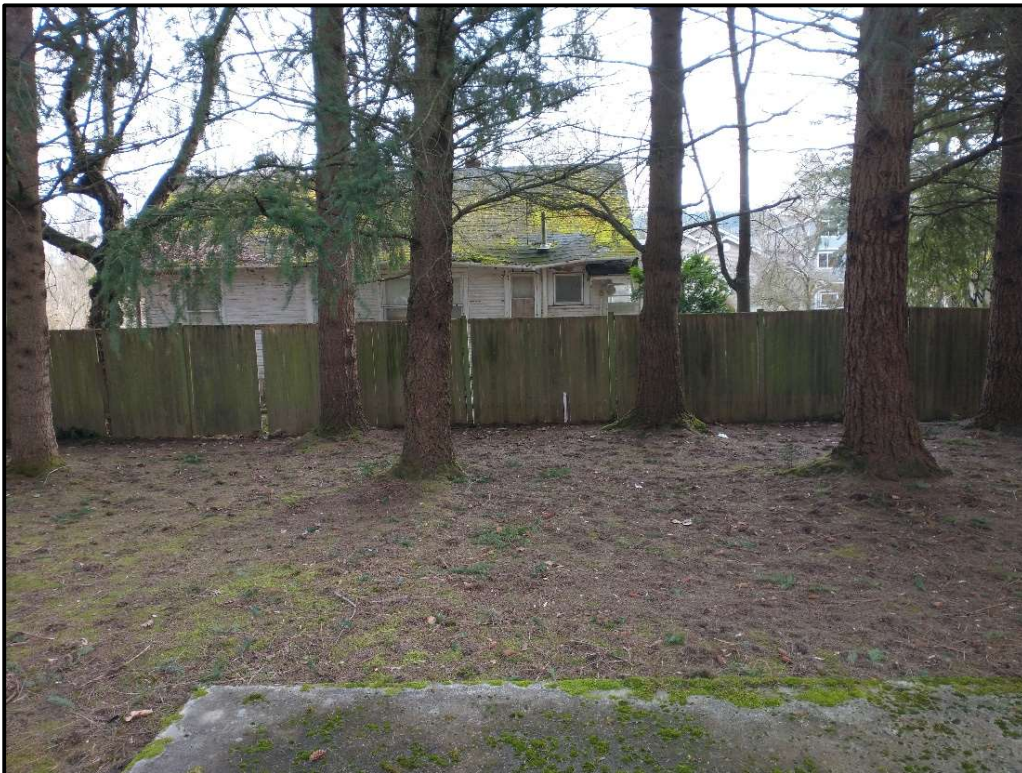
Photo 2. Base of trees 421 through 426 viewed from the basketball court to the west.

According to the plans, foundations for the proposed structures would be set 13 feet from tree 419, 17 feet from tree 421, 13 feet from tree 423, 21 feet from tree 424, and 17 feet from tree C.

To limit the required excavation and over excavation, I recommend the use of pier and beam foundations within CRZs and the use of elevated walkways to further limit ground disturbances. The use of alternative excavation such as hydro excavation or hand digging must be employed to excavate for the foundations within the CRZ of retained trees. The project arborist should be present for the excavation to assess root impacts and cut all roots encountered over one inch cleanly.

- Use alternative foundation systems within the CRZ of Trees 419, 421, 423, 424, and C.
- Tree protection consisting of chain-link fencing should be installed at the CRZ of all retained trees. Trees growing in a group should be protected at the edge of their shared TPZ. General tree protection specifications can be found below in Appendix B.
